## Stage II pressure ulcer caused by the connection of an electrocardiogram's nonstandard probe on the patient's chest: A case report study

**Cite this article:** Rafiei H. Stage II pressure ulcer caused by the connection of an electrocardiogram's nonstandard probe on the patient's chest: A case report study. Int J Epidemiol Health Sci 2020;1(1): e01. Doi:10.51757/IJEHS.1.1.2020.39686.

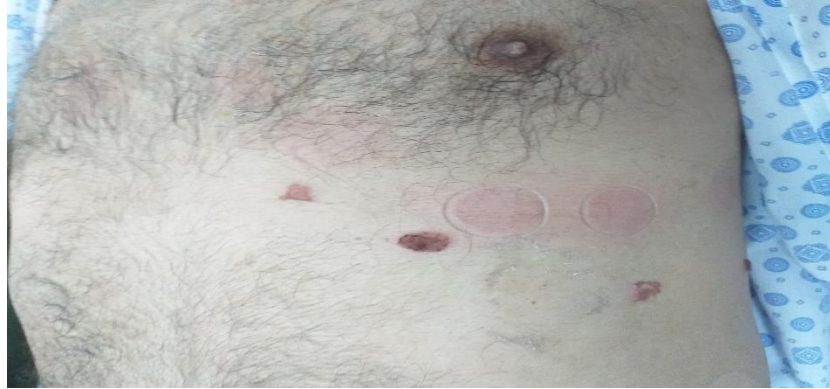
advanced treatment. After carrying out an ECG, the cardiac nurse noticed an ulcer on the patient's chest. The ulcer was on the left side of the sternum area and below the nipple. Careful examination showed that the damage was caused by excessive pressure related to the connection of the probe of the ECG to the patient's skin during the recording of the ECG. A thorough examination of the skin revealed two pressure ulcers, which both were in stage II (figure 1). Surprisingly, the nurses had not taken any action to treat the injuries.

**Figure 1.** Development of pressure ulcers due to the connection of a nonstandard probe of the ECG to the patient's chest.

One of the differences between MDRPUs and regular pressure ulcers is that there is no possible way to predict the risk of such damages by using a criterion, such as the Braden Scale for Predicting Pressure Ulcer Risk. For instance, if the Braden Scale was used for the studied patient in this case report, the patient would have a low risk for pressure ulcer development. Therefore, it is necessary to design a more optimized scale for predicting the risk of MDRPUs. Apart from this, it is important to bear in mind that the use of a nonstandard probe might result in skin damage and can thereby lead to the development of MDRPUs. To prevent such incidents in the future, it is of great importance to pay special attention to the probes that are being used for the recording of an ECG.
